Multiaxial fatigue of in-service aluminium longerons for helicopter rotor-blades

ABSTRACT. Fatigue cracking of longerons manufactured from Al-alloy AVT-1 for helicopter in-service rotor-blades was considered and crack growth period and equivalent of tensile stress for different blade sections were estimated. Complicated case of in-service blades multiaxial cyclically bending-rotating and tension can be considered based on introduced earlier master curve constructed for aluminum alloys in the simple case of uniaxial tension with stress R-ratio near to zero. Calculated equivalent tensile stress was compared for different blade sections and it was shown that in-service blades experienced not principle difference in this value in the crack growth direction by the investigated sections. It is not above the designed equivalent stress level. Crack growth period estimation in longerons based on fatigue striation spacing or meso-beach-marks measurements has shown that monitoring system introduced designer in longerons can be effectively used for in-time crack detecting independently on the failed section when can appeared because of various type of material faults or in-service damages.

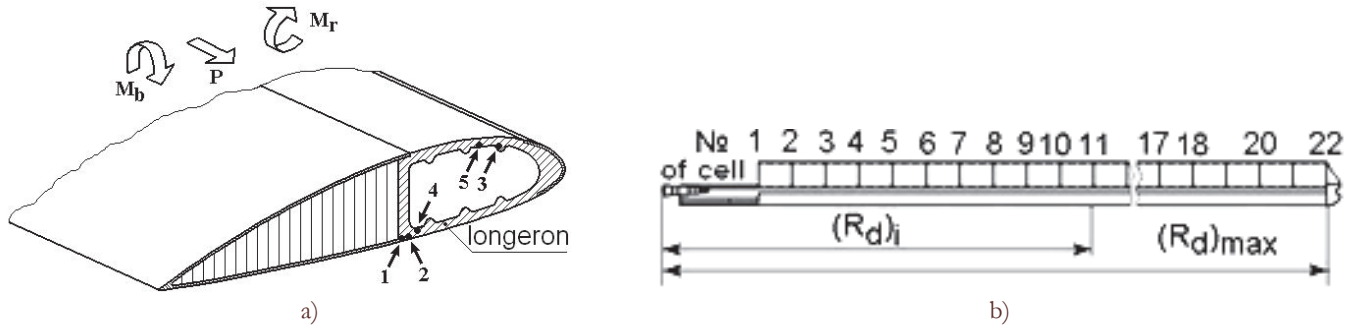
Figure 1: Scheme (a) of rotor-blade section with numbering “1”-“5” areas for crack origination and pointed out its external loading and (b) cells position for a blade.

In-service fatigue cracks nucleated in the longerons in the defect sites that were revealed all over the blade length, from $\bar{R} = 0.085$ to $\bar{R} = 0.71$, where $\bar{R} = (R_d)_i / (R_d)_{\max}$ (see Fig.1b).

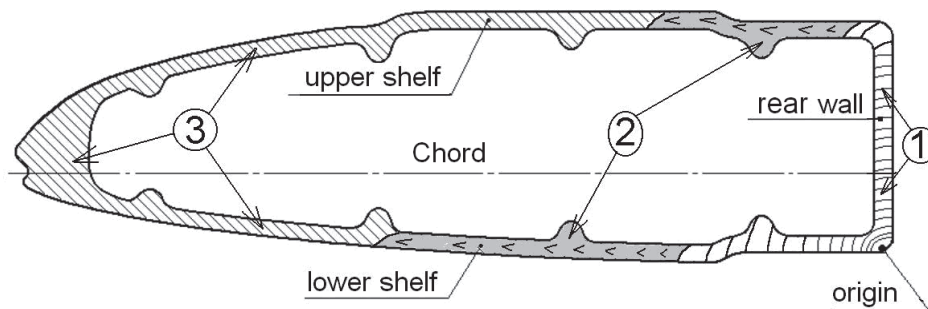
Fatigue cracks only nucleated in operating longerons of the rotor-blades if their material was somehow damaged [2, 3]. Despite the fact that the defects differed in the sites of location in the cross-section area of the longeron (see Fig. 1), all the defects caused failure of the fatigue nature. We can formalize these failure cases according to a general scheme of the fracture surface, Fig. 2, as composed of:

- a fracture-origin exhibits a fracture relief typical of the damage kind and may be located anywhere on the inner or outer surface of the longeron walls;
- a zone (1) of stable crack growth typically exhibits a smooth fracture surface with distinct mesoscopic or macroscopic (depending of the fracture location) beach-marks of fatigue fracture;
- a zone (2) of accelerated crack propagation typically shows a wavy fracture surface of the “Christmas-tree” or “chevron-like” type;
- a zone (3) of fast crack propagation when the plastic-shear lips form entirely over the wall-thickness of the longeron.

Figure 2: Scheme of longerons fracture surfaces for crack origination from the corrosion pitting with indication “1”-“3” different fracture surface areas.

All these calculations indicate that the fatigue fracture of the longeron was initiated as a result of high stress concentration in the corrosion-cracking site and not because of an overloading event.

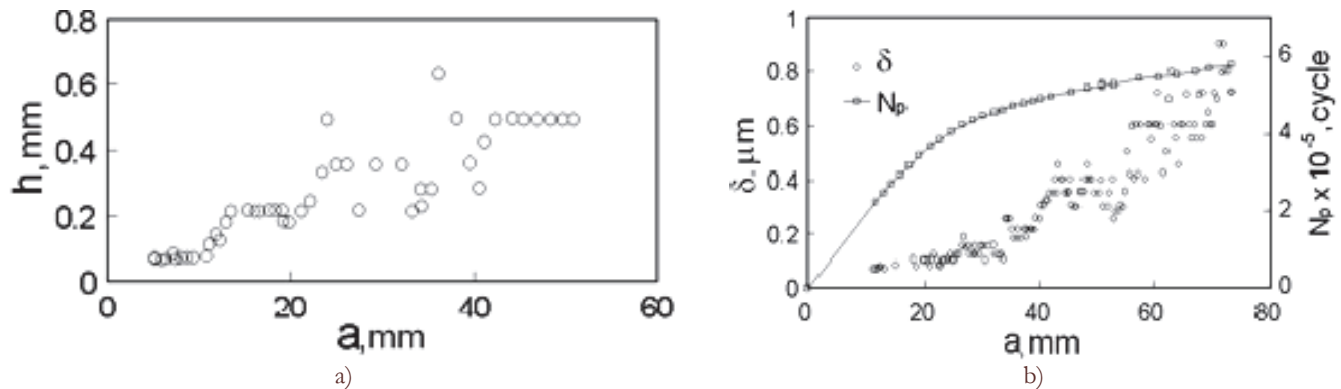
Sequentially measured distances between MBM and, then, between the Macro-Beach-Marks confirmed that the recurrence along the crack path is not casual, but regular, indicative of the very blade-loading patterns, regularly repeated with each single flight cycle, Fig. 3. Therefore, the regularly increasing distances between these marks are indicative of the crack-growth rate regularly increasing from flight to flight. And the number of these beach-marks corresponds to the number of the helicopter flights accomplished with the fatigue crack propagating in the longeron.

Figure 3: Spacing of (a) meso- or macro-beach-marks and (b) fatigue striations with number of cycles N_p against crack length a for two longerons (a) and (b).

Fatigue MBM were counted starting from the area 5.5 mm apart from the crack-origin site (the lines became most distinct here) to find out that the following crack-growth period involved about 210 flights. The inter-MBM distances (and, hence, the crack-length increments) appeared to sequentially increase. For the crack length grown from 5.5 to 7 mm, the average length increment did not exceed 0.056 mm per flight. So, not less than 70 flights were done with the fatigue crack growing in length from 1.5 to 5.5 mm. The starting crack length of 1.5 mm was taken a little greater than the depth (1.3 mm) of the stress-corrosion-origin. In total, these estimations give 280 (210 + 70) flight cycles for the period of crack propagation from the corrosion-cracking zone till the beginning point of unstable fracture.
